Project title: 287 Lisgar Street Redevelopment Risk Management Plan

Date of Project Progress Report: August 16, 2018

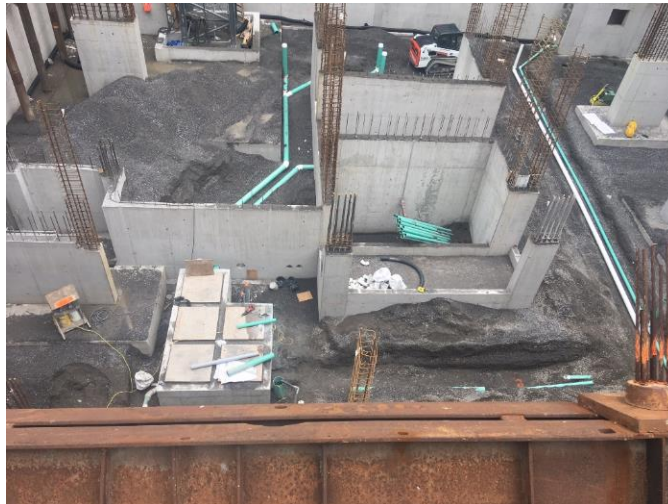
Photo 1: Layout of solid header pipes (tourquise colour) for sub-slab gas venting system

Selected photos are provided below showing the solid piping (headers) of the sub-slab venting (depressurization) system during construction.

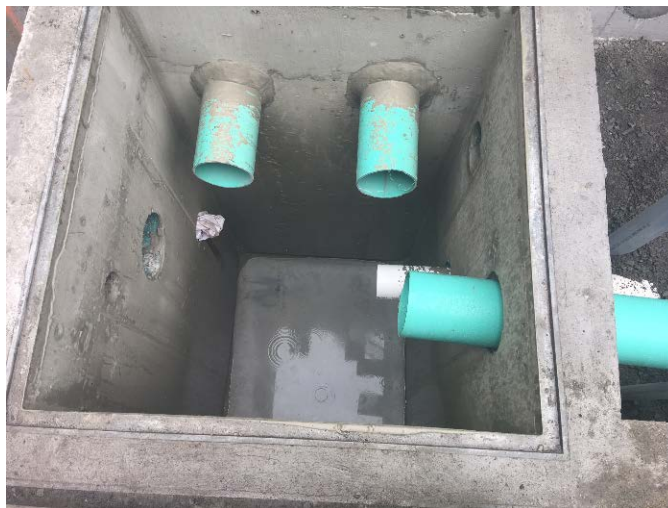
Photo 2: Air extraction piping at dedicated sump for the sub-slab gas venting system
